Avolites LTD Engineering Change Notice

ECN title	Mobile Fader wing Ref Resistor		
ECN Number	ECN-198		
Related Product(s)	All Mobile fader wings up to SN		
Date / Author	24/04/2015	JB Toby	AVOLITES
Reasons for ECN	Warm environment may trigger stuck faders on the Fader wing		
Parts required	120R (0603) Avo PN 8000-1010 (kit of 3 resistors)		
Tools required	T20 screwdriver, small soldering iron, tweezers		
Estimated time	30 Minutes

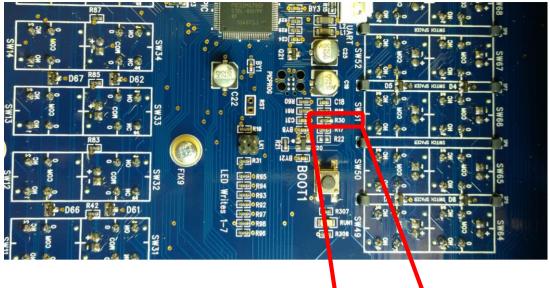
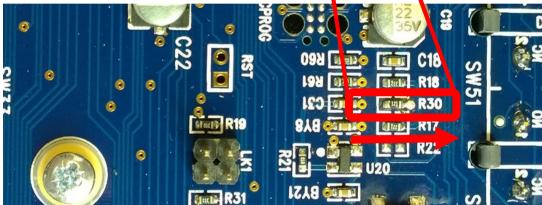
An increased temperature of the analog circuit inside the fader wing can cause the faders to never read zero, as a result playback faders are not released.

Locate R30 and remove it with a soldering iron, this is best done by swiping it towards the R30 legend (arrow)
