Avolites LTD Engineering Change Notice

ECN title	Mobile Fader wing Ref Resistor		
ECN Number	ECN-198		
Related Product(s)	All Mobile fader wings up to SN		
Date / Author	24/04/2015	JB Toby	AVOLITES
Reasons for ECN	Warm environment may trigger stuck faders on the Fader wing		
Parts required	120R (0603) Avo PN 8000-1010 (kit of 3 resistors)		
Tools required	T20 screwdriver, small soldering iron, tweezers		
Estimated time	30 Minutes

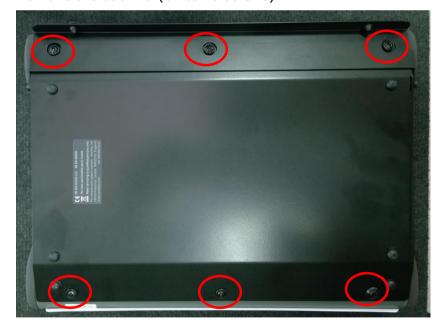
An increased temperature of the analog circuit inside the fader wing can cause the faders to never read zero, as a result playback faders are not released.

Remove the back lid (6x torks screws)

Locate R30 and remove it with a soldering iron, this is best done by swiping it towards the R30 legend (arrow)
